**FINAL REPORT OF THE
DEPARTMENT OF STATE POLICE**

**NEED FOR STANDARDS
FOR RECAPPED TIRES**

**TO THE GOVERNOR AND
THE GENERAL ASSEMBLY OF VIRGINIA**

HOUSE DOCUMENT NO. 24

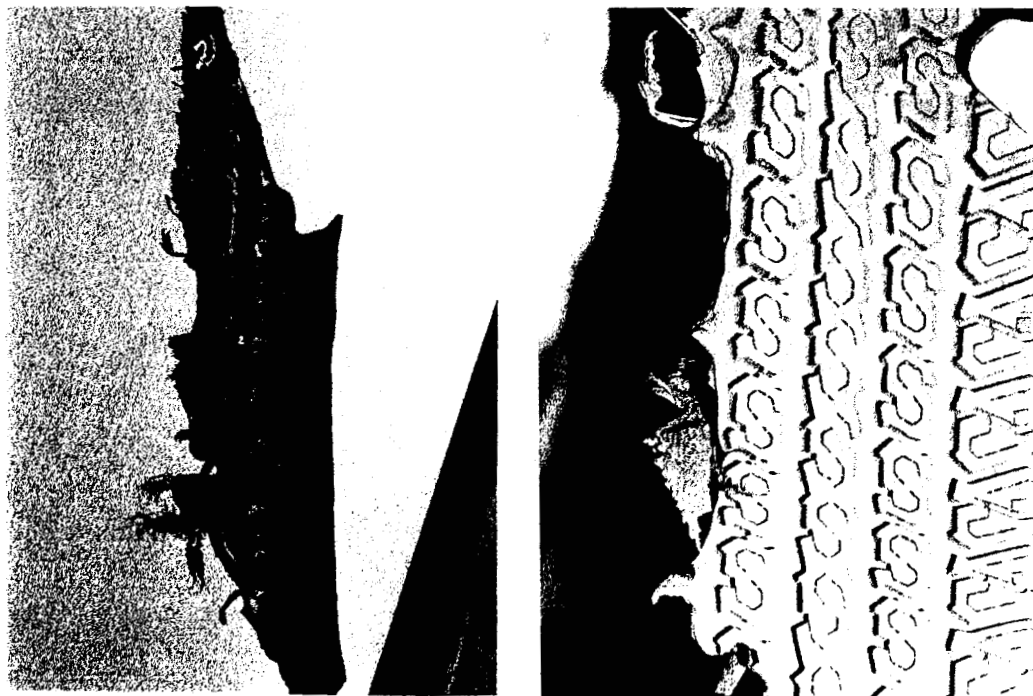
Exhibit #2 was a new passenger car or light truck tire, which could have been on a small trailer. The tire had minimum miles, and the tread depth was 10½/32 inch. Reason for failure was not conclusive, but indications made it more than likely the tire had insufficient air pressure.

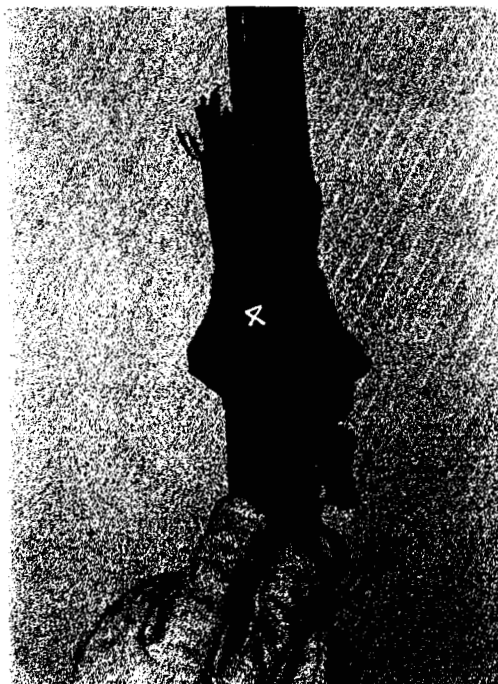
Exhibit #4 was a new light truck tire that was 3 years old or less, and the tread depth was 8/32 inch. There was not enough tire left to be conclusive, but the small pieces have evidence that indicate insufficient air pressure.

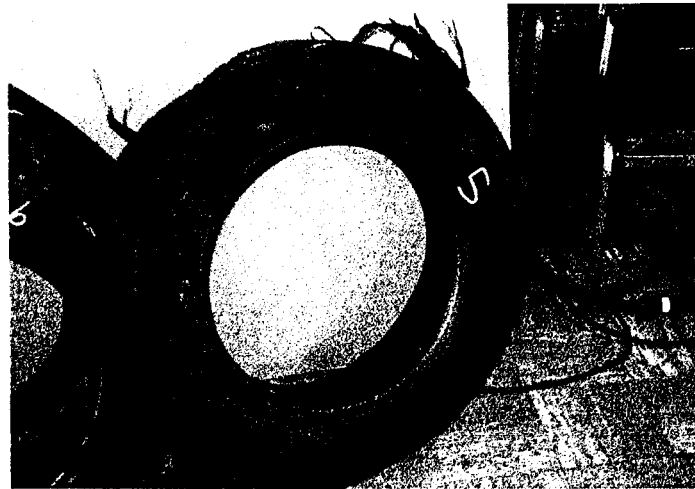
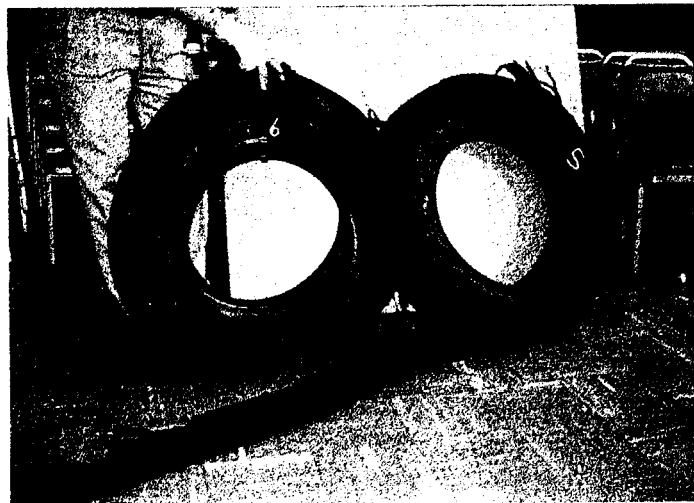
Exhibit #5 and #6 were new light truck tires that appeared to have been on the dual wheels of a motor home. The size of both tires was 8R 195, and the tread depth of #5 was 12/32 inch and #6 was 11/32 inch. Evidence indicated tire #6 was on the inside of the dual and went flat. Additional stress heated tire #6 until tire #5 was also destroyed. Both tires were changed beside the roadway and the old rubber was abandoned.

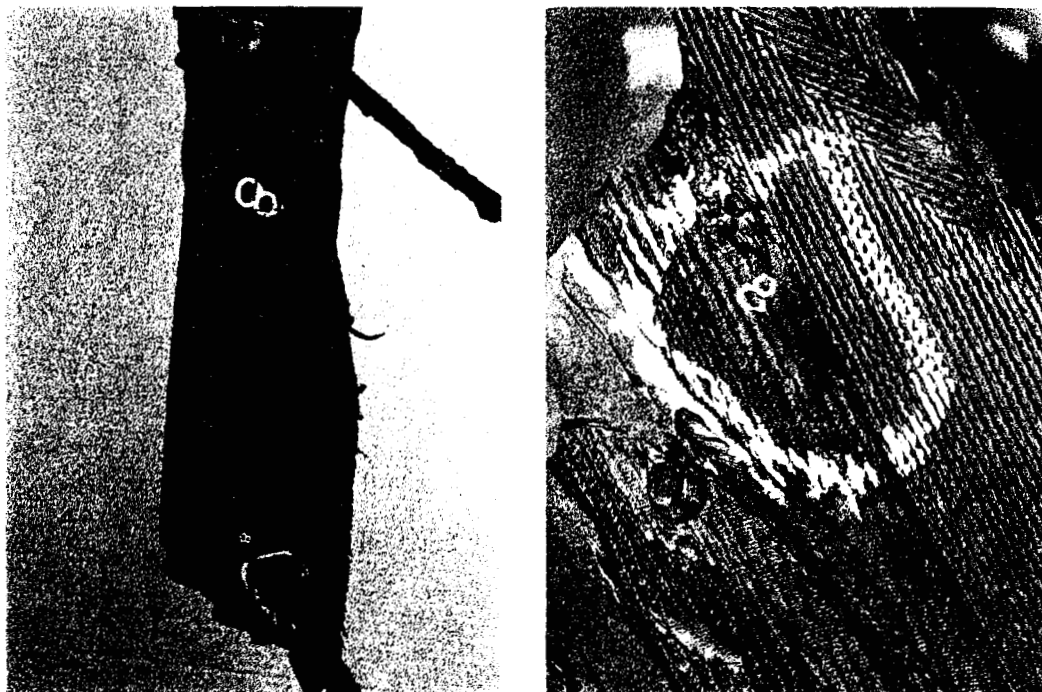
Exhibit #8 was a retreaded trailer tire with 9/32 inch tread remaining. Cause of failure was determined to be a puncture. The retread did not come off the casing, and the failure had nothing to do with the tire being a retread.

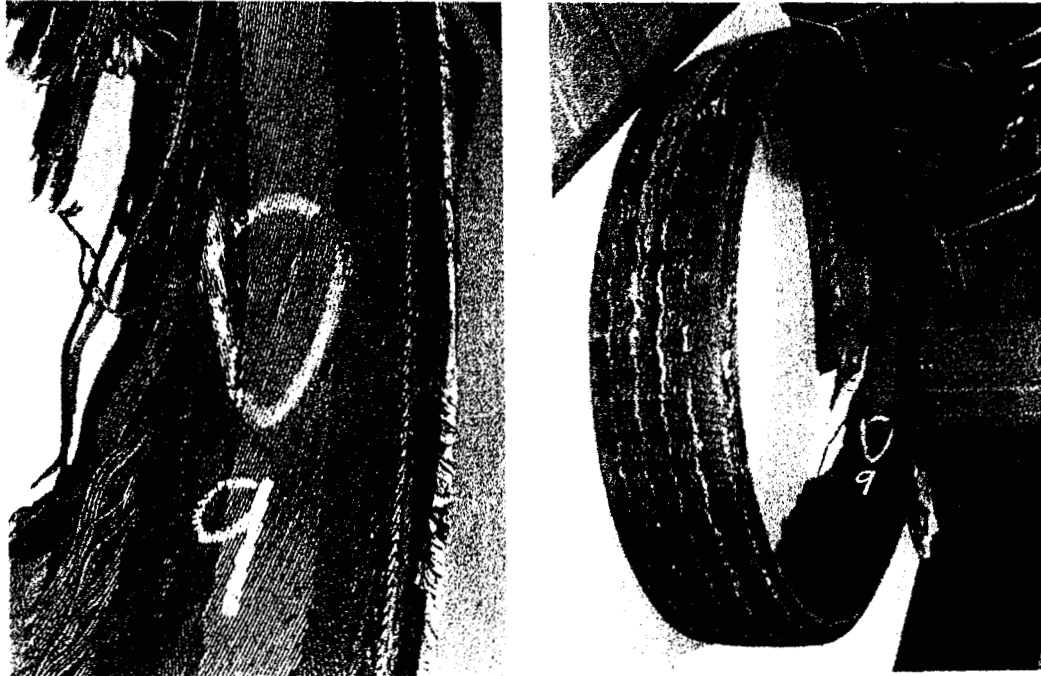
Exhibit #9 was a new retread with less than 20 miles traveled that had 15/32 inch tread depth. This tire came apart as the result of manufacturer's human error. The casing had a nail hole which was apparently missed during inspection prior to recapping, and the retread came off the casing immediately upon reaching travel heat levels.

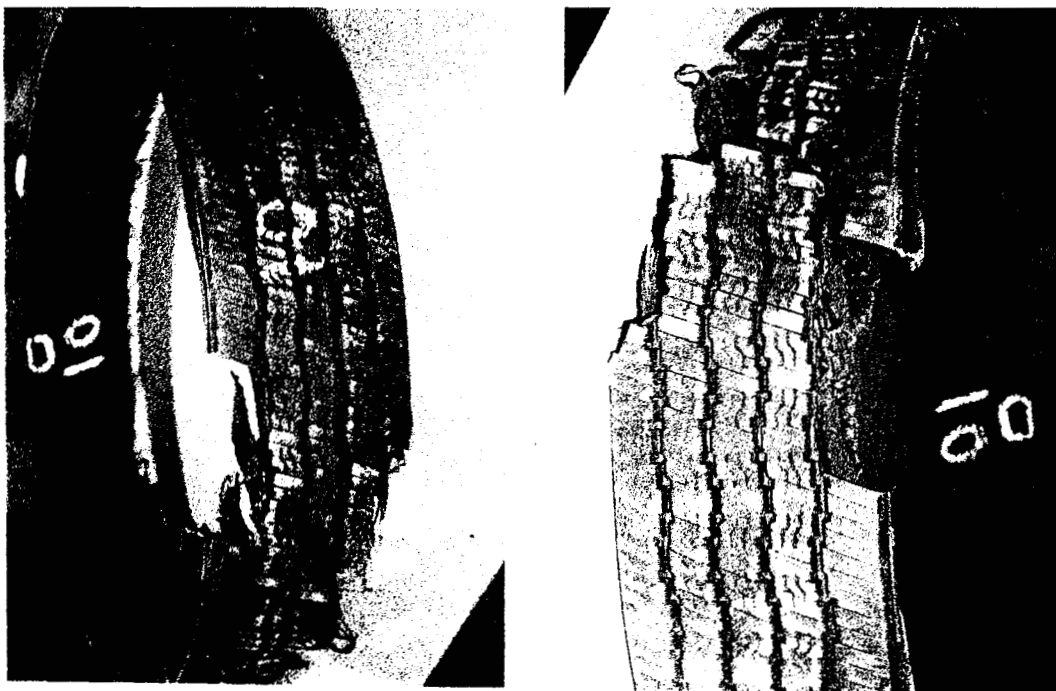
Exhibit #10 was a retreaded trailer tire with 12/32 inch tread depth. Original tread depth was 15/32 inch. A nail hole caused the tire to lose air pressure, and the tire overheated. The retread did not come apart, and the belt package was still intact.

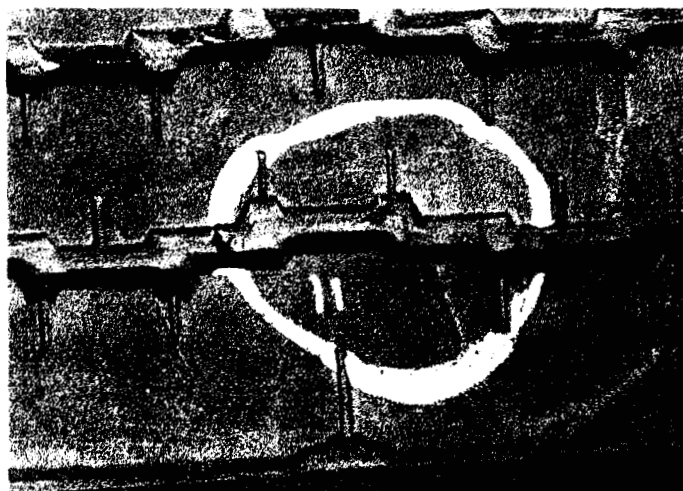
Exhibit #11 was a new retreaded trailer tire with 13/32 inch tread depth. A road hazard, such as a nail hole caused the tire to lose air pressure, and the tire overheated. The retread did not come apart, and the belt package was still intact.

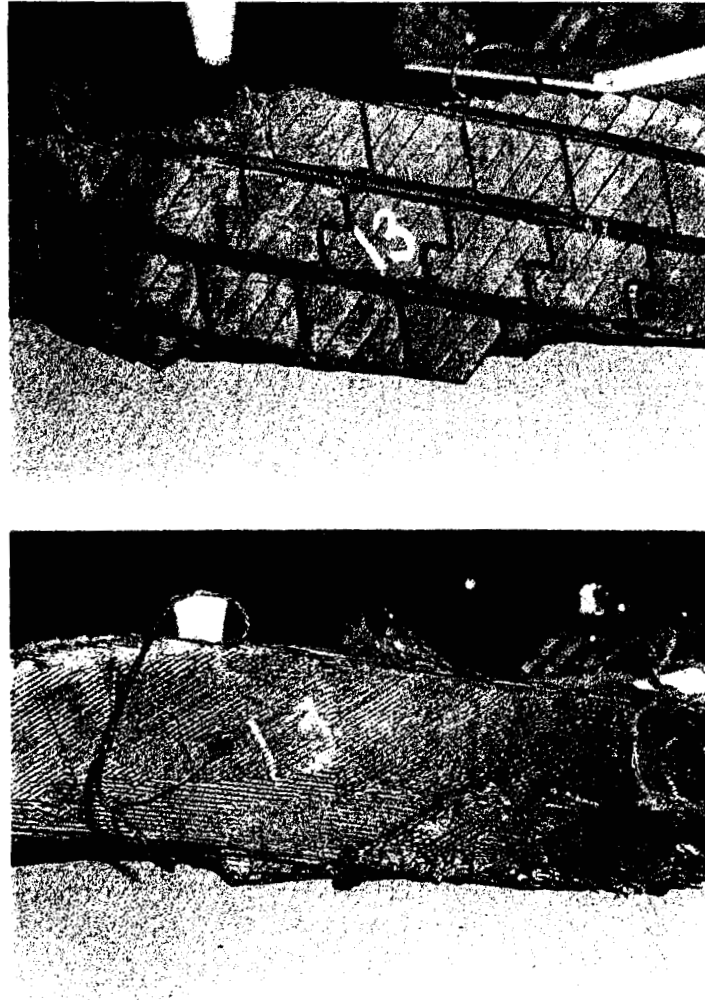
Exhibit #13 was a retreaded trailer tire with 8/32 inch tread depth. The original tread depth was 12/32 inch. There was not enough debris to determine cause of failure. The belt and retread were still together, and the failure occurred in the casing, as opposed to the retread.

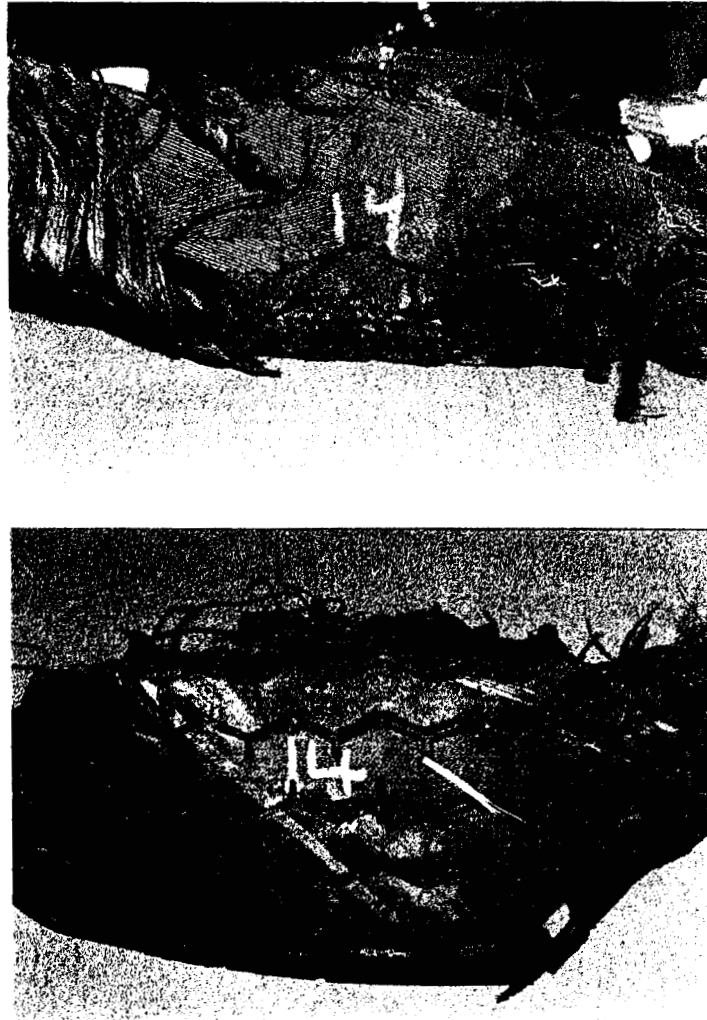
Exhibit #14 was a retreaded trailer tire with 8/32 inch tread depth. There was not enough debris to determine cause of failure. The belt and retread were still together, and the failure occurred in the casing, as opposed to the retread.

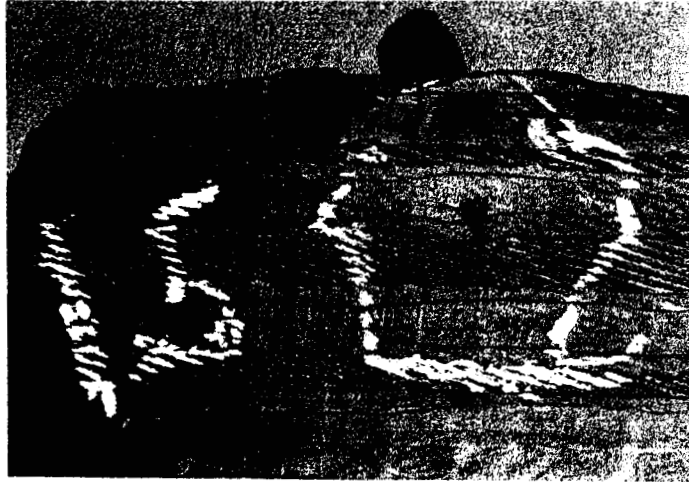
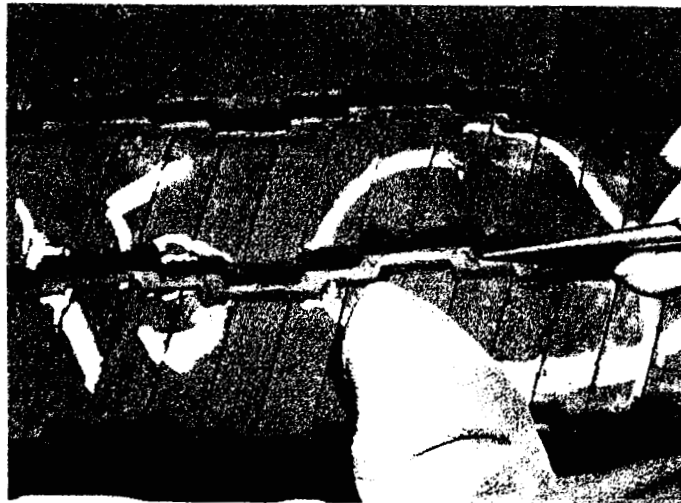
Exhibit #15 was a retreaded trailer tire with 9/32 inch tread depth. The original tread depth was 15/32 inch. A puncture caused the tire failure, and the belt and retread were not separated.

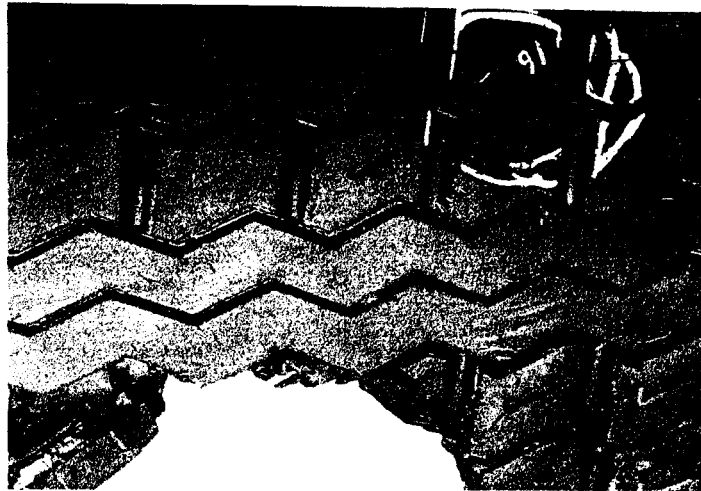
Exhibit #16 was a retreaded medium duty truck tire that would have been on the drive axle of the truck. The tire was almost new, with 18/32 inch tread depth. Cause of failure was a puncture through the tire, and the retread did not separate from the casing.

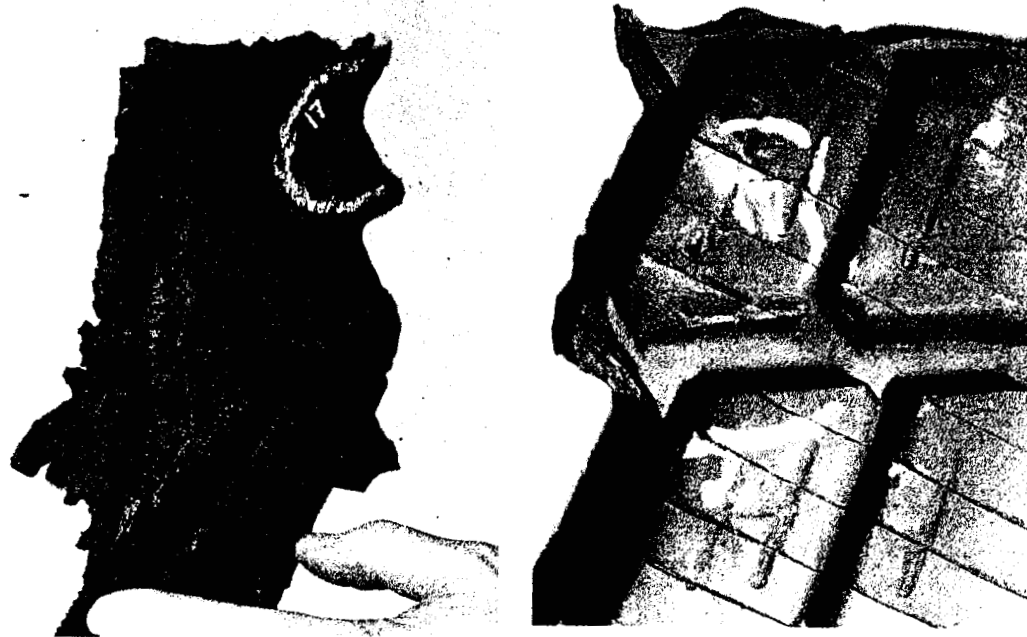
Exhibit #17 was a retread medium duty truck tire that was almost new, with 18/32 inch tread depth. Cause of failure was a puncture bolt hole through the tire, and the retread did not separate from the casing.

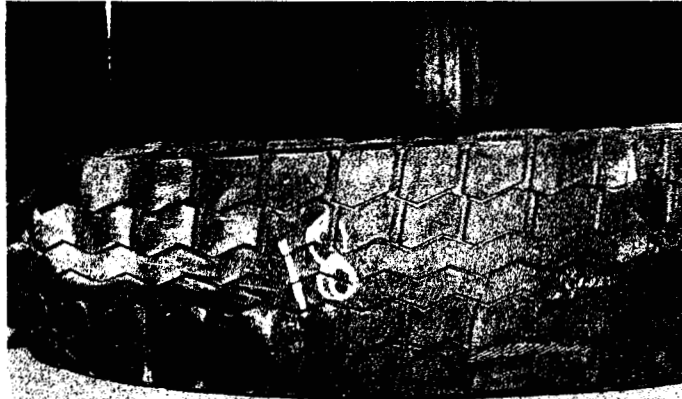
Exhibit #18 was a retread medium duty truck tire that had 9/32 inch tread depth. Cause of failure could not be determined, and the retread did not separate from the casing.

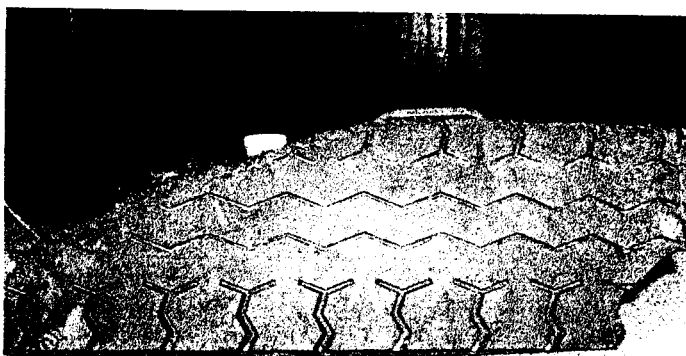
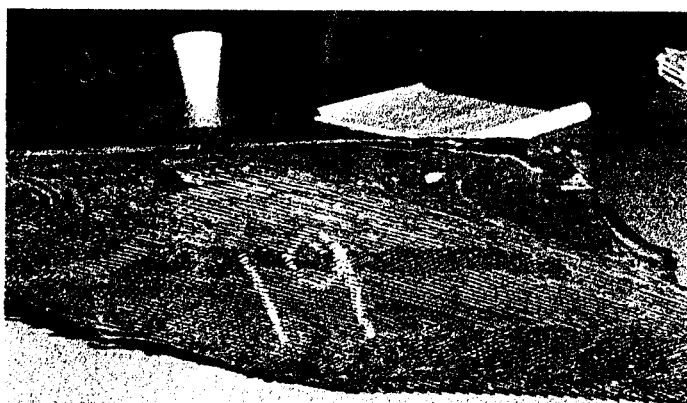
Exhibit #19 was a retread medium duty truck tire that had 6/32 inch tread depth. Cause of failure could not be determined, and the retread did not separate from the casing.

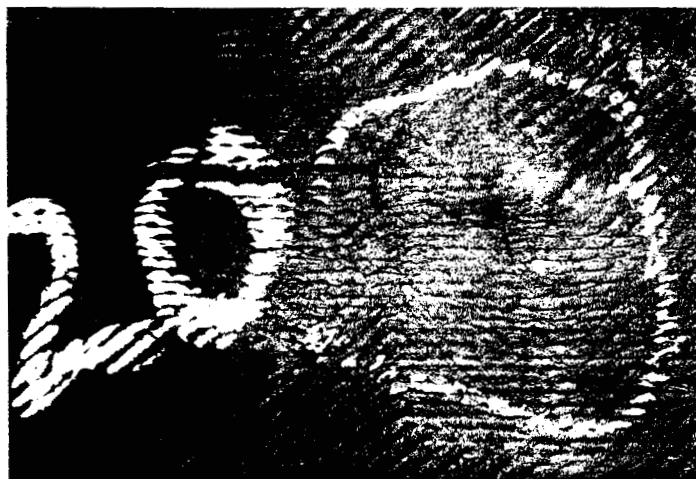
Exhibit #20 was a portion of a belt package only. It had been a retread tire and had a puncture hole. With only a number of belt sections, the tire type could not be determined.

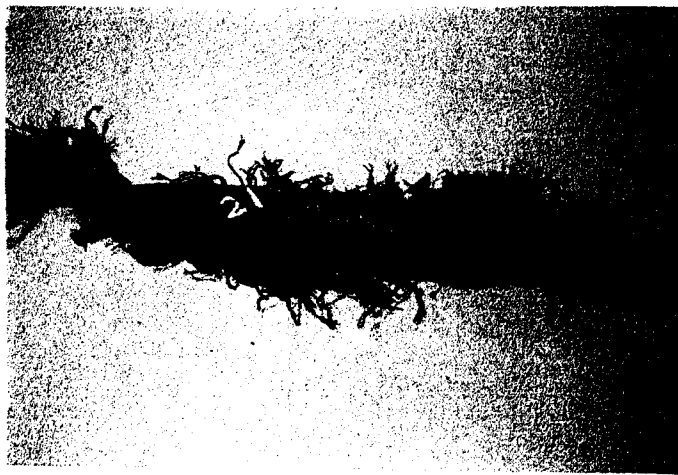
Exhibit #21 was a nylon bias/ply tire with no belts. It is the type usually found on containerized trailers, referred to as Intermodal, that are used to transfer containerized loads from one mode of transportation to another. This was a heat-generated blowout, but due to lack of additional materials, there was no way to determine tread depth. This tire may or may not have been a retread.

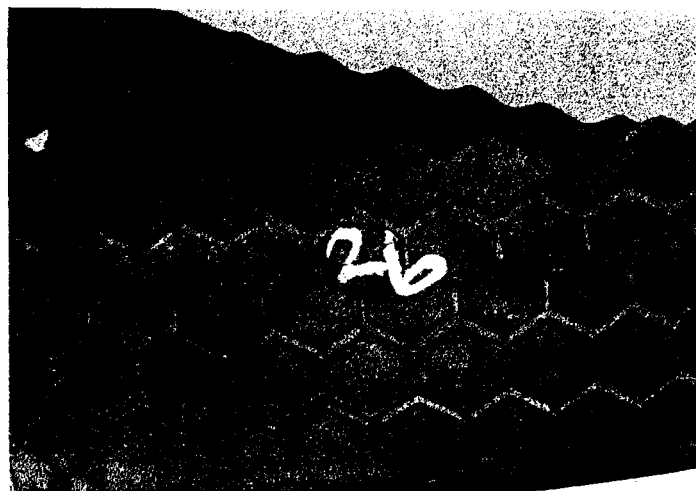
Exhibits #26 and #27 came from a group of seven different tires, with at least five of them being the type usually found on containerized trailers, referred to as Intermodal, that are used to transfer containerized loads from one mode of transportation to another. The tires were not radial and were cheap casings. Of the seven, five were retreads, one was new, and one could have been either. Three of the tires had been recapped twice.
